Safety evaluation of Matitan reservoir dam

Haoran Shi¹, Yao Yang¹, Xiaoqing Liu¹ and Hailing Li²

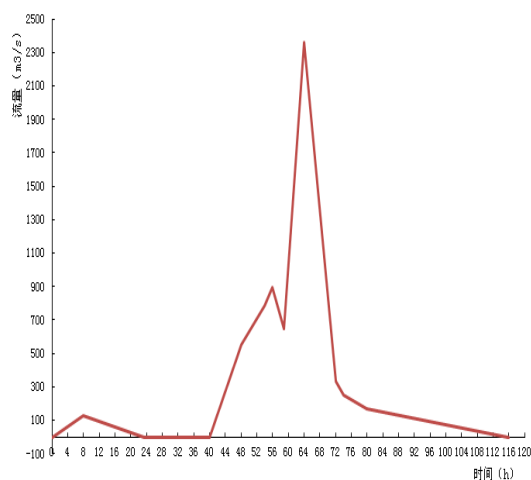
Fig.1:Flood process line(P=2%)

The Matitan Reservoir has no measured flood data, so when we calculate the statistics of storms according to the "Manual of middle and small watershed storm flood computation in Sichuan Province", we ascertain the dam's design flood and check the results' reasonability with rational formula. The ascertained plan flood process line is shown in figure 1, figure 2.

The reservoir's normal pool level is 549.85 m, the original design flood level is 552.55 m, the original check flood level is 553.55 m. According to the current standard review, we get the reservoir's calculated design flood level of 553.45 m, and check flood level of 554.66 m, respectively 0.9 m and 1.11 m higher than original corresponding water levels. Under the same design standards condition, review results are more reliable compared to the original design results.
