Research of the deterioration mechanism and the prevention techniques of the main structure of conveyor gallery in colliery industrial environment

Key words: colliery industrial environment; main structure of conveyor gallery; deterioration mechanism; prevention techniques

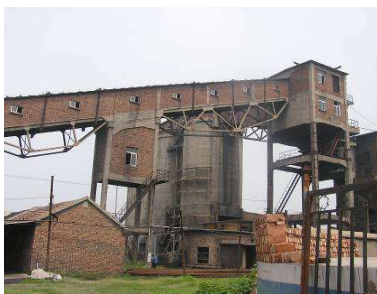
The conveyor galleries in Jiahe, Chacheng, Woniushan and Zhangji colliery were built in the 1960s~1990s (Parts appearance were shown in Figure 1. General situation can be seen in table 1). They are reinforced concrete structures. Base, support frame and conveyor comprise the conveyor galleries. The conveyor itself is made up of precast reinforced concrete truss, precast reinforced concrete slab and retaining structure. The conveyor contains steel component. The unique usage and artisan of the conveyor make the environment even worse. The frequent alternation of dry and humid air, the continuously increasing concentration of poisonous gas and liquid ion, the accumulation of solid attachments on the component, and long-term vibration load all contribute to the severe deterioration of the structural component, such as cracking of surface concrete, reinforcement rust, which pose a great threat to normal production and safety.

Fig 1: The main structure of belt corridor of ChaCheng coal

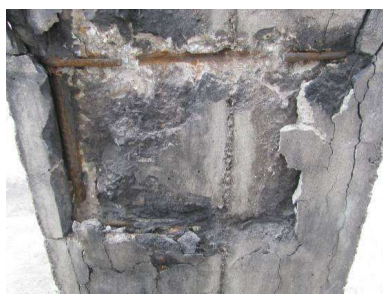
The frequent alternation of dry and humid air, the gas, liquid and solid poisonous media, and the longtime vibration all contribute to the reinforcement rust, concrete cracking and surface concrete falling. Crack width is concentrated in 0.56 mm to 3.93 mm. The rust rate ranges from 6.00% to 16.00%. Moreover, the corbel is also influenced by the conveyor, and therefore suffers more deterioration. The deterioration is so severe that the concrete cannot meet the designed requirement. Some appearance can be seen in Figure 2 and 3.

Fig 2: Concrete crumbling and steel bar rusting

For the supporting frame, the severely deteriorated concrete should be removed first. After anti-rust processes are carried out for the rebars, polymer or modified mortar or concrete is used to restore the concrete component. Then for those components which have insufficient capacity, enlarge their section area or attach carbon fiber. Last, put on 20mm-thick polymer mortar for protection.

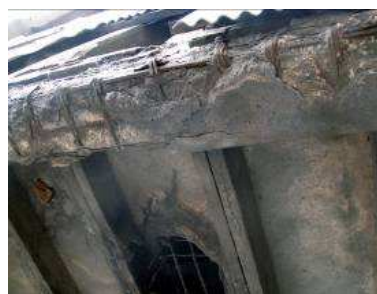
Fig 3: Concrete crumbling and steel bar rusting

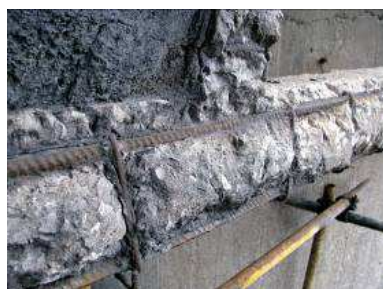
Fig 4: Truss component corrosion serious

Concrete crumbling is of great significance and widespread in precise reinforced concrete truss bracing. Reinforced concrete beam, slab and opening show cracking and bar rusting on the top and at the bottom of some bracing. The concrete deteriorates so severely that it cannot meet the design requirement. Some of the steel component of conveyor gallery shows some extent of rust. Rust rate of C shape beam ranges from 5% to 15% and rust rate of angle bracing ranges from 5% to 10%. Part appearance of the truss component can be seen from Figure 4 and 5. The test results of member and material can be seen in table 5.

For the conveyor, the severely deteriorated concrete should be removed first. After anti-rust process esare carried out for the rebars, polymer or modified mortar or concrete are used to restore the concrete component. Then for those components which have insufficient capacity, are attached to carbon fiber and put on 20mm-thick polymer mortar for protection. For C-shape steel beam, after the removal of rust, is attached to glass or carbon fiber and then put on 20mm-thick polymer mortar for protection. For steel components, after the removal of rust, smear anti-rust lacquer.

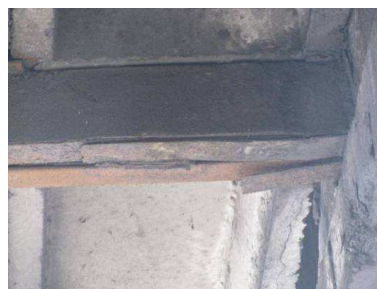
Fig 5: Steel component corrosion serious
