The test analysis of transmission gears' fatigue pitting

Zhifei Wu, Tie Wang and Ruiliang Zhang

There were severe pitting corruptions on the surface of transmission gears in diesels. The cause of metal fatigue pitting of gear surface is analyzed in the paper, which based on the contact fatigue experiment of 18Cr2Ni4WA carburizing and quenching gears used in the diesel engine. Causes of pitting on harden tooth surface are studied from three aspects: gear surface residual stress field, oil film pressure and carburizing thickness, which according to the morphology of test gear fatigue fracture and the surface hardening properties of carburizing and quenching gears. The reasons of experimental gears' contact fatigue pitting were analyzed and conclusions were as follows: The depth of the diffusion layer, surface carbon concentration and the carbon concentration gradient of layer were the key to improve the ability to resist wear surface fatigue pitting.

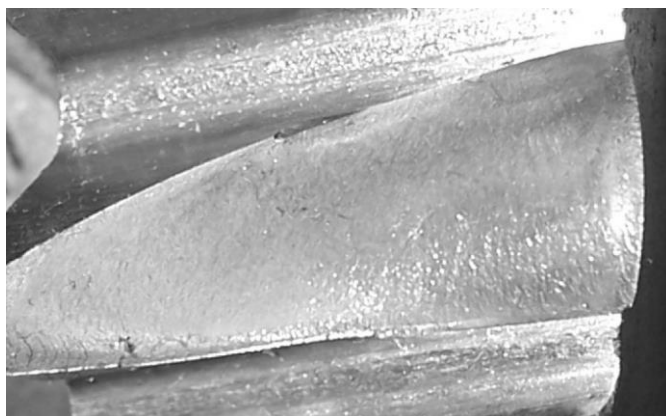
This phenomenon could be interpreted in accordance with Figure 4, when the gears mesh layer of residual compressive stress to shear stress smaller, but the transition region remaining tensile stress caused the shear stress to increase, such transition region became the weakest region, moreover in the transmission process tooth surface relative sliding had the friction force. Frictional shear stress would also be added to the shear stress, caused the peak value to increase and present the position on the surface layer migratory. This allows maximum shear stress occurred in the sub-surface. Thus the germination and expansion of fatigue crack were under the surface.

Fig.4 The morphology of test gear fatigue fracture

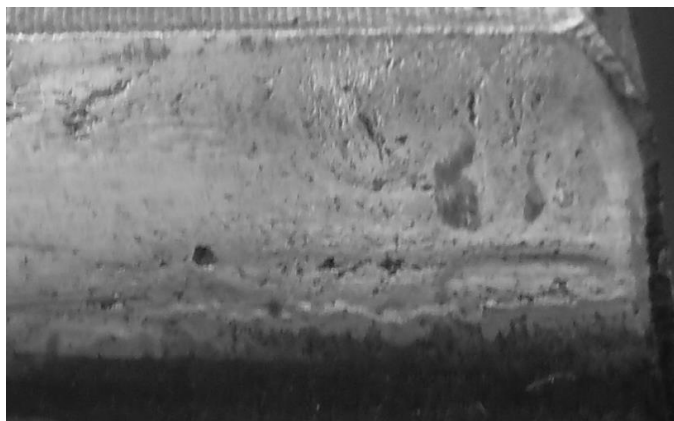
The growth of surface fatigue was influenced by complex factors, such as stress distribution, growth of generally thinks the surface fatigue crack initiation the macroscopic stress distribution, the fine texture and the environment. There were many pitting and fatigue cracking area on the experimental gear tooth surface shown in Figure 5, but only a few cracks could expand to pitting corrosion shown as Figure 2 which near the pitch line.

Fig.5 The morphology of gear surface fatigue crack

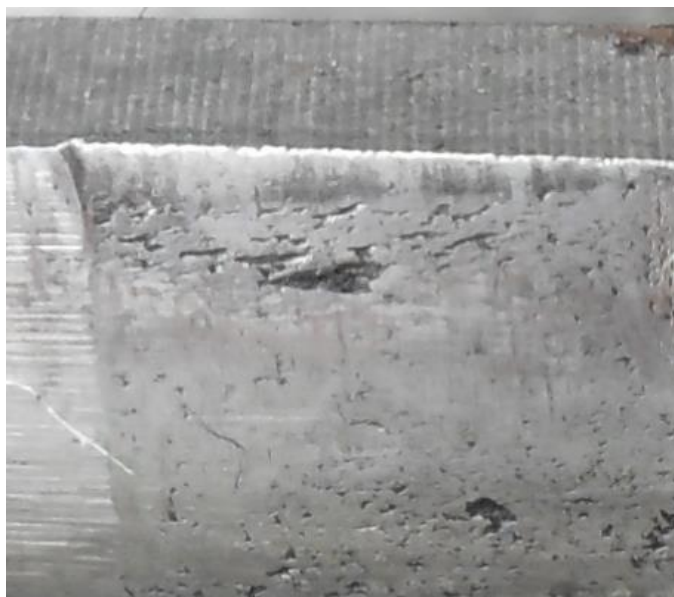
The lubricant film pressure was considered as the critical factor of pitting growth in some research, however, the oil wedge function forms the lubricant film pressure peak value did not as large as literature [12] predicted values, which due to the plastic deformation of tooth surfaces, therefore the peak value of pressure was not the key aspect which formed the hard tooth surface gear pitting shown in Figure 6, however, the contact on section line accelerated the section near the fatigue crack growth.

Fig.6 The morphology of gear addendum fatigue crack

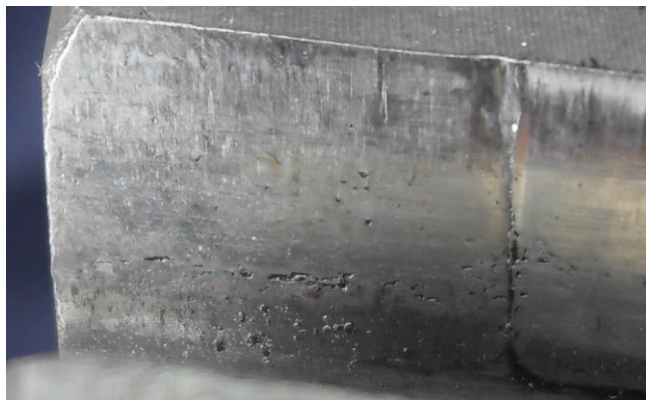
When the depth of carburizing was tiny, the contact fatigue crack stemmed from the tooth surface frequently showed in Figure 7, while the running-in just begun, the tooth surface has not had the plastic deformation, and the flaking formed in no time. It was due to the depth of carburized layer was not enough, and the fatigue crack initiation appeared in the transition region.

Fig.7 The morphology of surface fatigue during running-in

The gear operating conditions, heat treatment factors and energy consumption were comprehensively considered, the carburizing depth should be suitable, and the decisive factor was the nice gradient distribution, therefore the ideal cementation region requested high hardness and smooth transitive on sub-surface.
