Study on the slope stability of typical super-high tailings dam with using the centerline method to dam

Key words: Tailings dam; Geotechnical investigation; Tailings deposition law; Dam stability

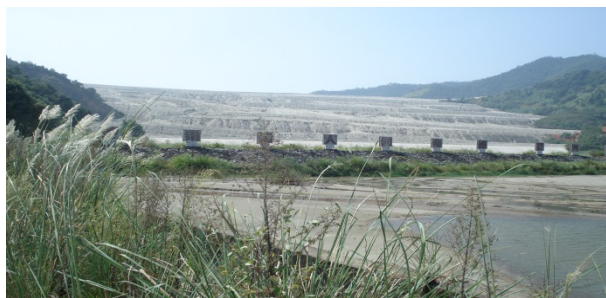
Figure 1 On-site photo of high tailings dam

At present, due to the particularities of the tailings dam, foreign countries such as the countries of European Union, Canada and Australia, etc. pay great attention to the safety of the tailings dam, in particular, the stability of the tailings dam in earthquake. Seid[2] analyzed the Mochikoshi tailings dam by using commercial software FLAC, and discussed the seismic resistant measures briefly. Ishihara [3] analyzed the seismic stability of Mochikoshi tailings dam with the theory of the residual strength. Troncoso[4] studied the dynamic characteristics of tailings sands of a silt mine under the earthquake load, also concluded that the silt tailings sands with fine particles tend to be liqueficient. Finn [5] studied the dynamic strength and characteristics of the tailings sludge/slurry? and also considered that the tailings sludge/slurry with more fine particles tend to be liqueficient. While in China, some studies have been done in the dynamic and static stability of tailings dams and some achievements have been reached. Wang Wenxing[6] believed that the excess pore water pressure is an important factor that influences the seismic stability of a tailings dam. Wang Feiyue[7] applied the fuzzy theory to the research of the stability of the tailing dams for the first time for the reliability analysis method of the fuzzy and random in tailings dam engineering, which provides a new way for the calculation of the tailings dam stability. Yuan Bing[8] studied the liquefaction identification of tailing dams specifically and put forward a simplified identification method by which the earthquake magnitude, the tailings median particle diameter, relative density, static stress, and physical mechanical indexes of tailings are taken into comprehensive consideration. RuanYuancen[9] studied the static and dynamic characteristics of the tailings, and pointed out the complexity of the research on tailings. Li Xingxing[10] analyzed the dynamic finite element of tailings dams and his results showed that the dam body's damage becomes more serious and dam stability also worse when the seismic frequency is closer to the natural frequency of the tailings dam, the earthquake lasts longer and acceleration becomes greater. Although domestic and foreign scholars have made many achievements in the stability of rock fill dams up to now, there are little research results in the stability analysis of central line embanked high tailings dam. Therefore, in this paper, some research of the stability of the high tailings dam has been made based on the site investigation and indoor experiments for the high tailings dam of a copper mind in Jiangxi Province and its on-site photo is shown in Figure 1.

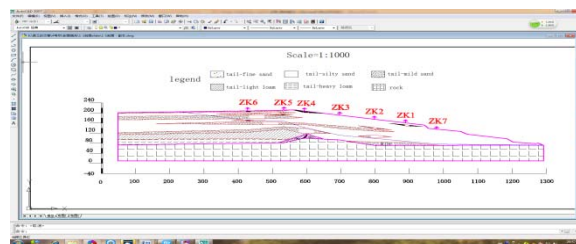
Fig 3 geological map of tailings deposition rules with 1-1 section(unit:m)

Based on the drilling results during the site geological prospecting and the indoor geotechnical test results of tailings samples obtained by the State Key Laboratory of Geomechanics and Geotechnical Engineering, Wuhan Institute of Rock and Soil Mechanics, Chinese Academy of Sciences, it is known that the tailings accumulations are composed of 5 kinds of tailings materials: tail-fine sand, tail-silty sand, tail-mild sand, tail-light loam and tail-heavy loam. the geological map of tailings deposition rules with the 1-1 section is shown in the Figure 3.

(1) The exploration results suggest that the sediment rules of center line embankment is as follows: the tendency of tailings from coarse to fine is obvious from dam area to reservoir while that is not so obvious from top to bottom. The sedimentary beach of the tailings dam is slow and flat in shape. No tailings sludge (slime) layer is found during the drilling.

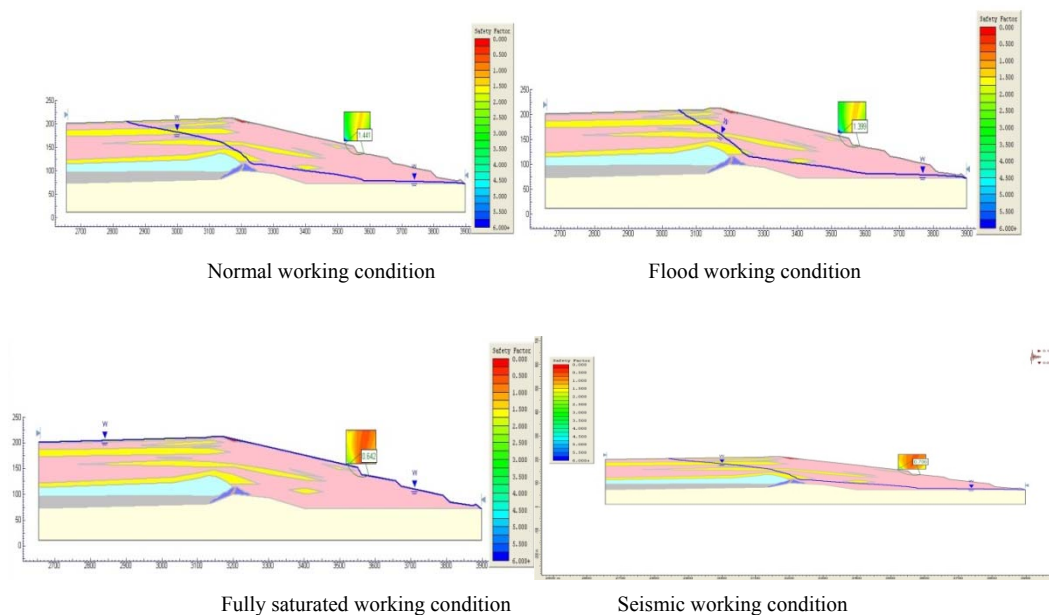
Fig 4 Calculation of dam stability

Calculation approach	Working conditions	Computational safety coefficient	Minimum safety coefficient required in the specifications
Scheme I	Normal working condition	1.441	1.30
Scheme II	Flood working condition	1.399	1.20
Scheme III	Fully saturated working condition	0.642	1.20
Scheme IV	Seismic working condition	0.714	1.10

From the calculation results, it can be seen that in the case that the tailings dam in normal and flood working conditions, without the earthquake taken into consideration, are basically safe under its current crest height. However, in fully saturated working conditions, the calculated safety coefficient cannot meet the requirements of the specifications, and the slippage may come into being. Thus, the tailings dam should be avoided from running in the fully saturated conditions. The calculation results can be seen in Fig 4.

(2) When the tailings dam is in normal or flood working conditions, the calculated safety coefficient can meet the requirements of the specifications and the tailings dam is relatively stable. While the tailings dam is in full saturation working conditions, the calculated safety coefficient is far below the requirements of the specifications and the stability of dam decreases obviously, which leads to the extreme instability of the dam.
