Water damage mechanism of surface and downstream side of spur dike

ABSTRACT

At present the research on water damage mechanism of spur dike are more confined to dike head, but that a large number of water damage phenomenon happened in the dike surface and downstream slope is found through analysing the field investigation and experimental phenomenon. This article first simulates the boundary condition on water damage of dike surface and downstream slope, and then observe the process of washout, so that reveals its mechanism. When the dike body is riprapping, destructive flow condition of recession period and the next flood season, leading to the unstable of dike body and the large pressure difference between its front and back, will cause dike surface and downstream slope be destroyed. When the dike body is riprapping and dike surface is concrete hinge, stream of overflowing dam with an apparently downward acting force causes the serious erosion on the downstream side. With the development of the scour process, local large permeable rate basis area will be scoured much more seriously. When the dam surface is unable to bear the force down to the dam crest from the downward water fl

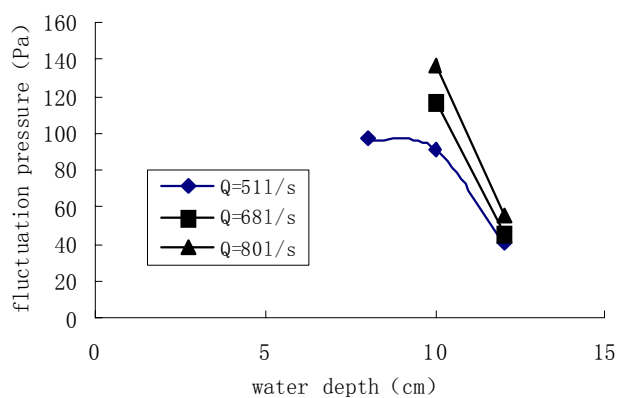
**Figure 6. Effect of water depth on fluctuation pressure**

As shown in Figure 5, the total pressure and the fluctuation pressure on the dike body increases with the increasing water depth. Moreover, the increasing speed the total pressure with an increase of water depth is bigger than that of hydrostatic pressure, which explains that the destruction of dike is mainly caused by the hydrodynamic pressure and the fluctuation pressure. In other words, the influence of hydrostatic pressure is smaller. It can be seen from Figure 6 that the fluctuation pressure on the dike body doesn't vary in the vertical direction when the water surface is under the top of dike. However, when the spur dike is submerged the fluctuation pressure will reduce with an increase of water depth. This indicates that for the case of water surface over the top of dike the turbulence around dike head will have certain extent reduction with an increasing water depth, and the pulsation velocity and the fluctuation pressure will have a certain extent of reduction as well.

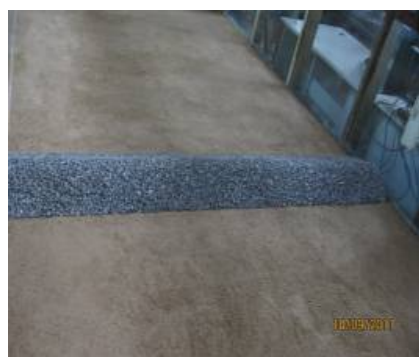
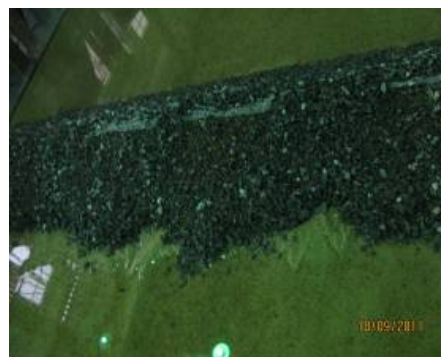
(a)Not scoured

(b)Scoured

Figure 7. Comparison chart of prior to erosion and after erosion of enrockment dam body which is local enlarged

According to the initial boundary conditions mentioned above, flow is discharged and level is debugged. After water level is stable, the first measurement runs. Analysis results are shown in table 3 and Figure 7.

As seen in table 3, at the beginning, when the drop is only 3.1cm, flow velocity of dam face can only in-duces a little gravel to start and rolling and causes slight damage. With the fall of level and the gradual in-crease of drop in front and behind dam, the level of damage becomes larger. After each debug of water level, when flow velocity begins to change, dam face is damaged apparently. When new slope is formed due to the rolling or sliding, dam body restores stability until the whole dam crest is damaged completely finally. Figure 7 shows the difference of prior to erosion and after erosion in dam body local enlarged pattern. It illustrates that damage of dam body takes place on dam crest firstly and concentrated in the dam crest and back slope of dike. And collapse and rolling of gravel are main failure modes. Some deposit occurs in back slope of dike due to the low permeable rate. This phenomenon also occurs in filed investigation.
